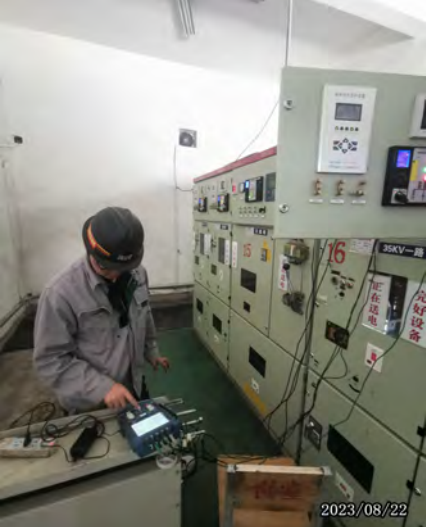
序号	报告编号	发布日期	结论	影像资料
12	GX-B1404/20-2-23035	2023. 10. 9	<p>所检电网谐波电压总谐波畸变率、各次谐波电压含有率、谐波电流符合GB/T 14549-1993 《电能质量 公用电网谐波》要求。</p>

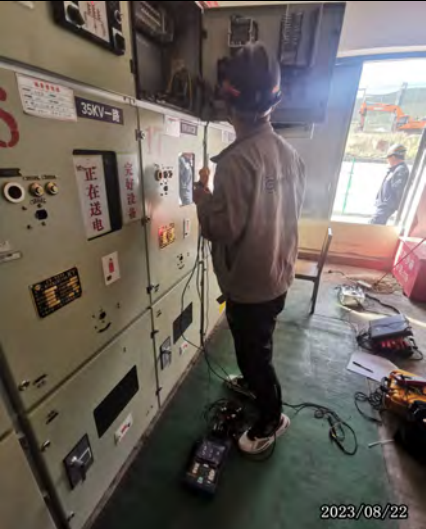
13	GX-B1404/20-2-23036	2023. 10. 9	<p>所检电网谐波电压总谐波畸变率、各次谐波电压含有率、谐波电流符合GB/T 14549-1993 《电能质量 公用电网谐波》要求。</p>
