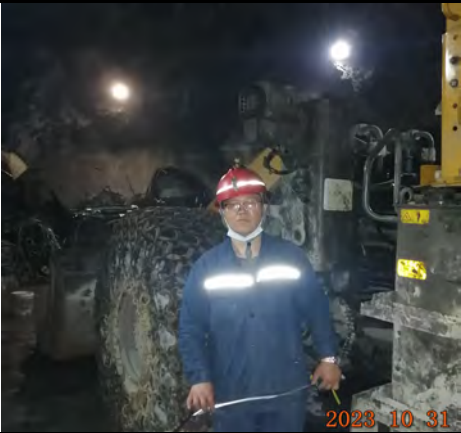
147	GX-B1539/22-6-23005	2023/11/23	所检项目合格	 
148	GX-B1539/22-6-23006	2023/11/23	所检项目合格

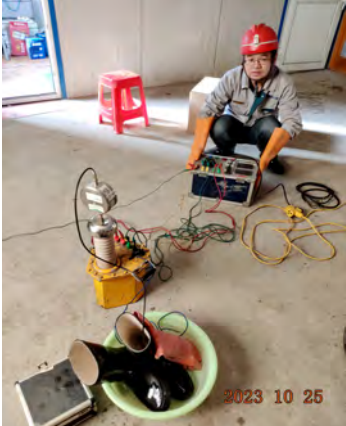
150	GX-B1328/20-6-23158	2023/11/27	所检项目合格	 
151	GX-B1328/20-6-23152	2023/11/20	所检项目合格

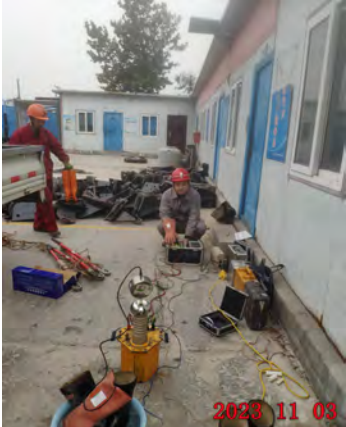
152	GX-B1328/20-6-23153	2023/11/27	所检项目合格

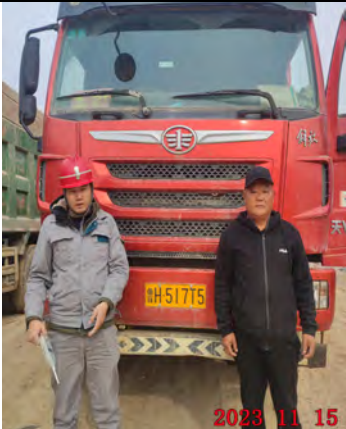
195	GX-B1423/20-6-231151	2023.11.27	综合判定：合格

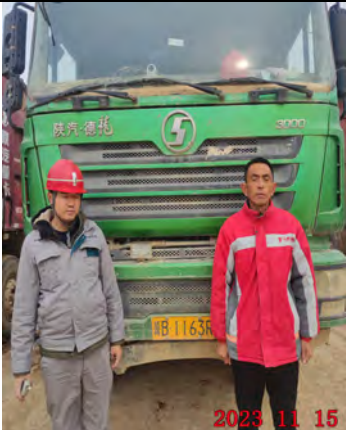
196	GX-B1423/20-6-231152	2023.11.27	综合判定：合格

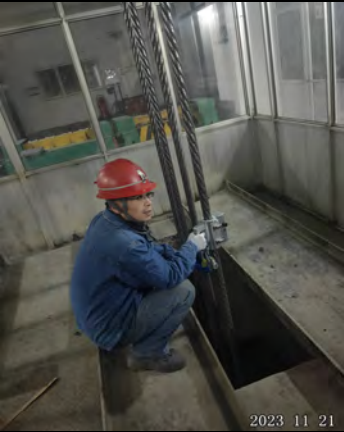
222	GX-B1598/21-6-23074	2023/11/30	实测钢丝绳有效截面积损失百分比最大为2.23%，小于5%为正常。

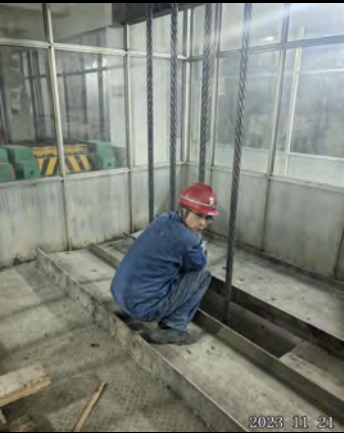
223	GX-B1598/21-6-23075	2023/11/30	实测钢丝绳有效截面积损失百分比最大为1.43%，小于5%为正常。

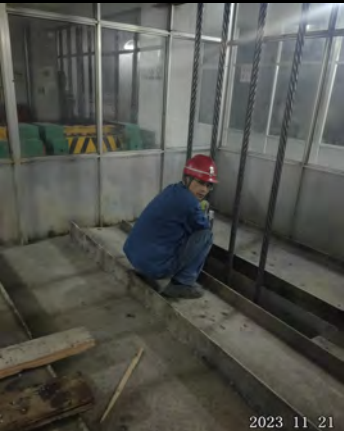
224	GX-B1598/21-6-23076	2023/11/30	实测钢丝绳有效截面积损失百分比最大为1.31%，小于5%为正常。

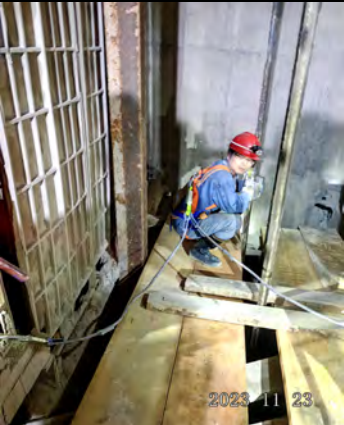
228	GX-B1598/21-6-23080	2023/11/30	实测钢丝绳有效截面积损失百分比最大为1.59%，小于5%为正常。
