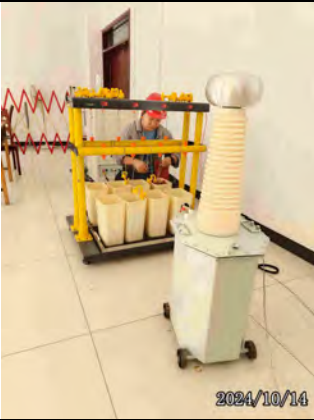
63	GX-B1328/20-2-24105	2024. 10. 21	所检项目合格。
